# Manhole Inspection Summary

Manhole # S33C\_\_012MH

Insp Date: **8/12/09 12:31 PM**

**Location** Address: **200 Saratoga St**

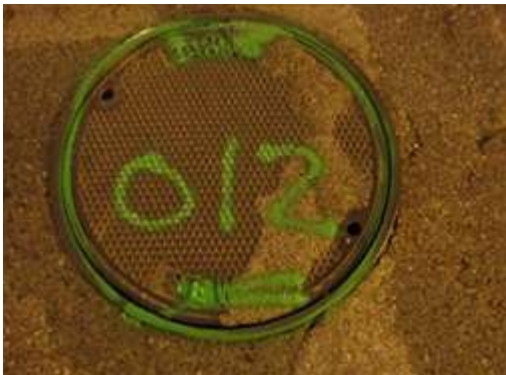
MH Cover View

**Cover** Shape: **Circular** Diameter: **25.** (in.) Length: **0** (in.) Dist A/B Grade: **0** (in.)  
**75**

Type: **Sanitary** Condition: **Sound** Cover Material: **Cast Iron**

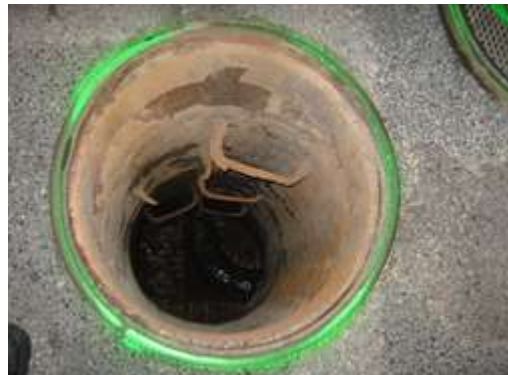
Frame View

**Frame** Offset: **3** (in.) Condition: ☒ Sound ☐ Cracked ☐ Leaks

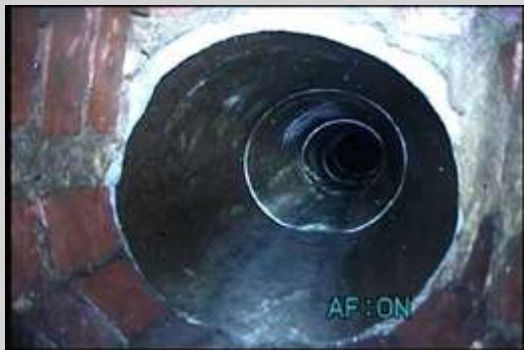
12 O'Clock Outflow

12 in. Circular Gravity Sewer  
Pipe Out @ 12 O'Clock

Pipe Height: **12** (in.) Rod and Bar (Angled)  
Pipe Material: **Clay** ☐ Pipe Lined  
Invert Depth: **13.10** (ft.) Flow Characteristics: **Slow**  
Deposits: ☒ None ☐ Mud ☐ Sludge ☐ Debris ☐ Grease  
Silt Depth: **0** (in.) Deposits Extent:  
Infiltration: **None** Pipe Seal Cond: **Sound**

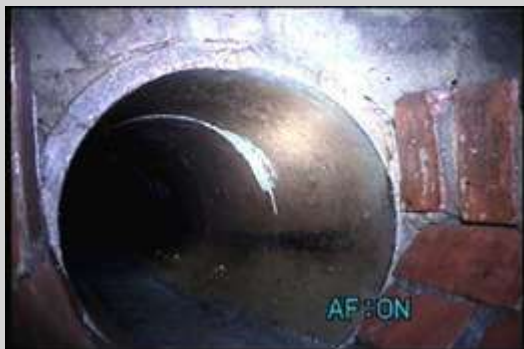
3 O'Clock Inflow

10 in. Circular Gravity Sewer  
Pipe In @ 3 O'Clock

Pipe Height: **10.8** (in.) Rod and Bar (Angled)  
Pipe Material: **Clay** ☐ Pipe Lined  
Invert Depth: **12.84** (ft.) Flow Characteristics: **Slow**  
Deposits: ☒ None ☐ Mud ☐ Sludge ☐ Debris ☐ Grease  
Silt Depth: **0** (in.) Deposits Extent:  
Infiltration: **None** Pipe Seal Cond: **Sound**
